## **Periodic Inspection of Jetties at Manasquan Inlet, New Jersey**

**Armor Unit Monitoring for Period 1994-1998**

*by Robert R. Bottin, Jr., WES  
William F. Rothert, Philadelphia District*

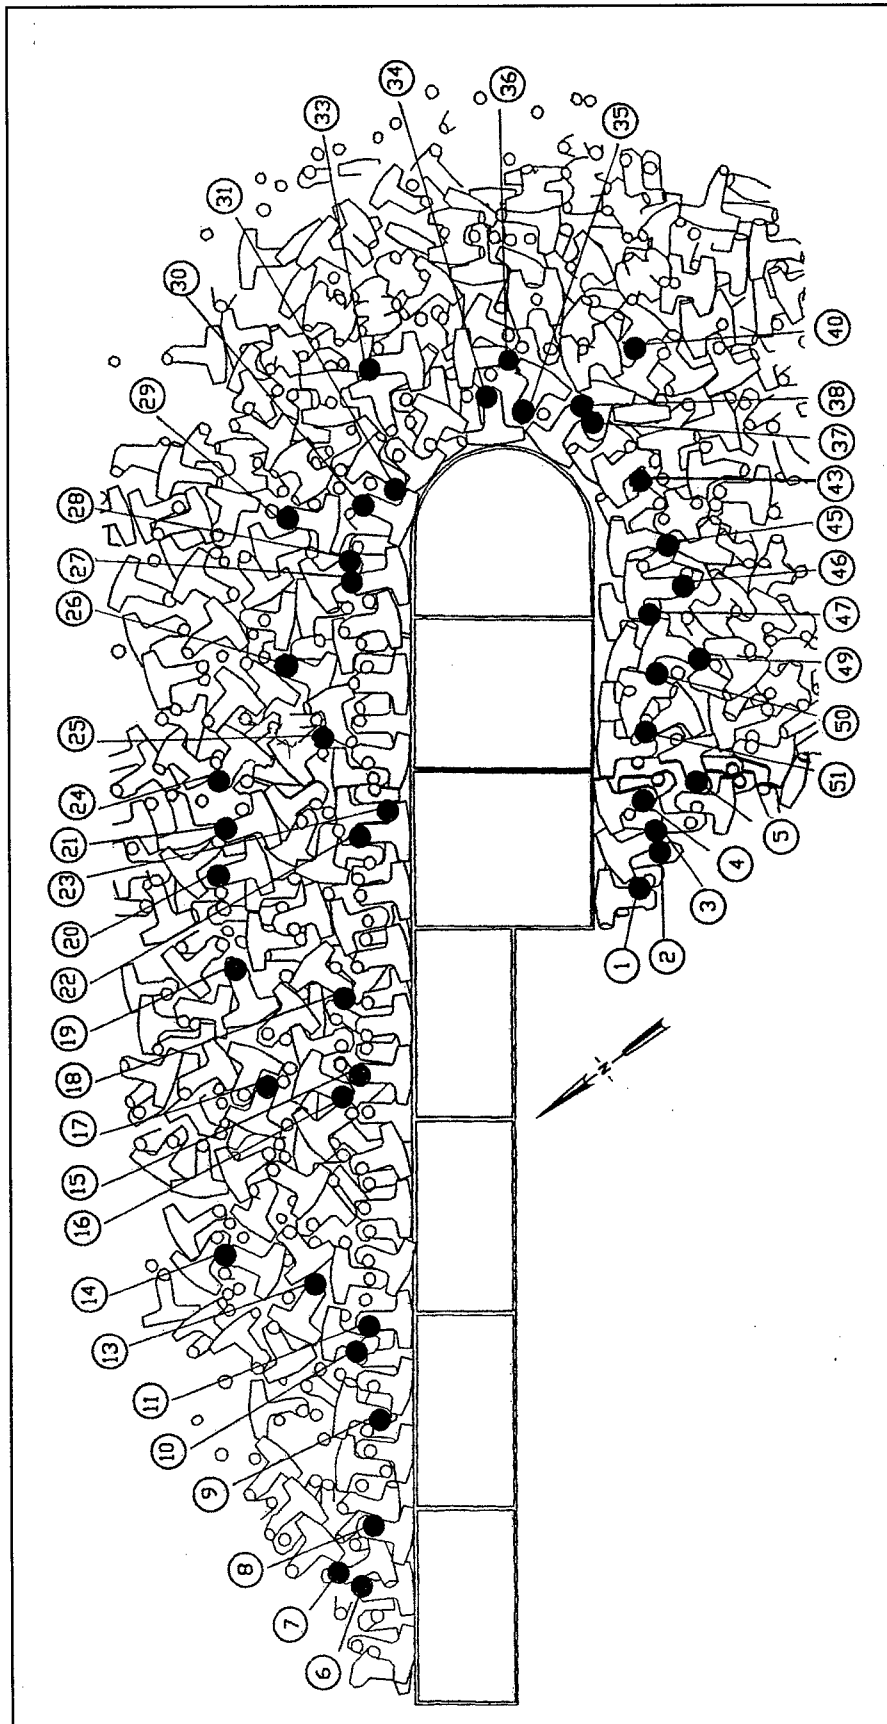
Figure 15. Locations of targeted dolosse on north jetty

were inadvertently missed. The actual locations of the targeted dolosse distributed over the north and south jetties are shown in Figures 15 and 16, respectively. Numbers correspond to the originally established targets. Targets also were established on the new CORE-LOC armor units installed on the heads of the jetties during the October 1997 rehabilitation. Sixteen CORE-LOCs on the north jetty and 12 on the south jetty were targeted. Their locations are shown in Figures 17 and 18. In addition to the painted black crosses, the center of each target was marked with a drill hole 0.64 cm (0.25 in.) in diameter and 0.64 cm (0.25 in.) deep to aid in identifying targeted units in subsequent surveys. A typical target established on an armor unit is shown in Figure 19.

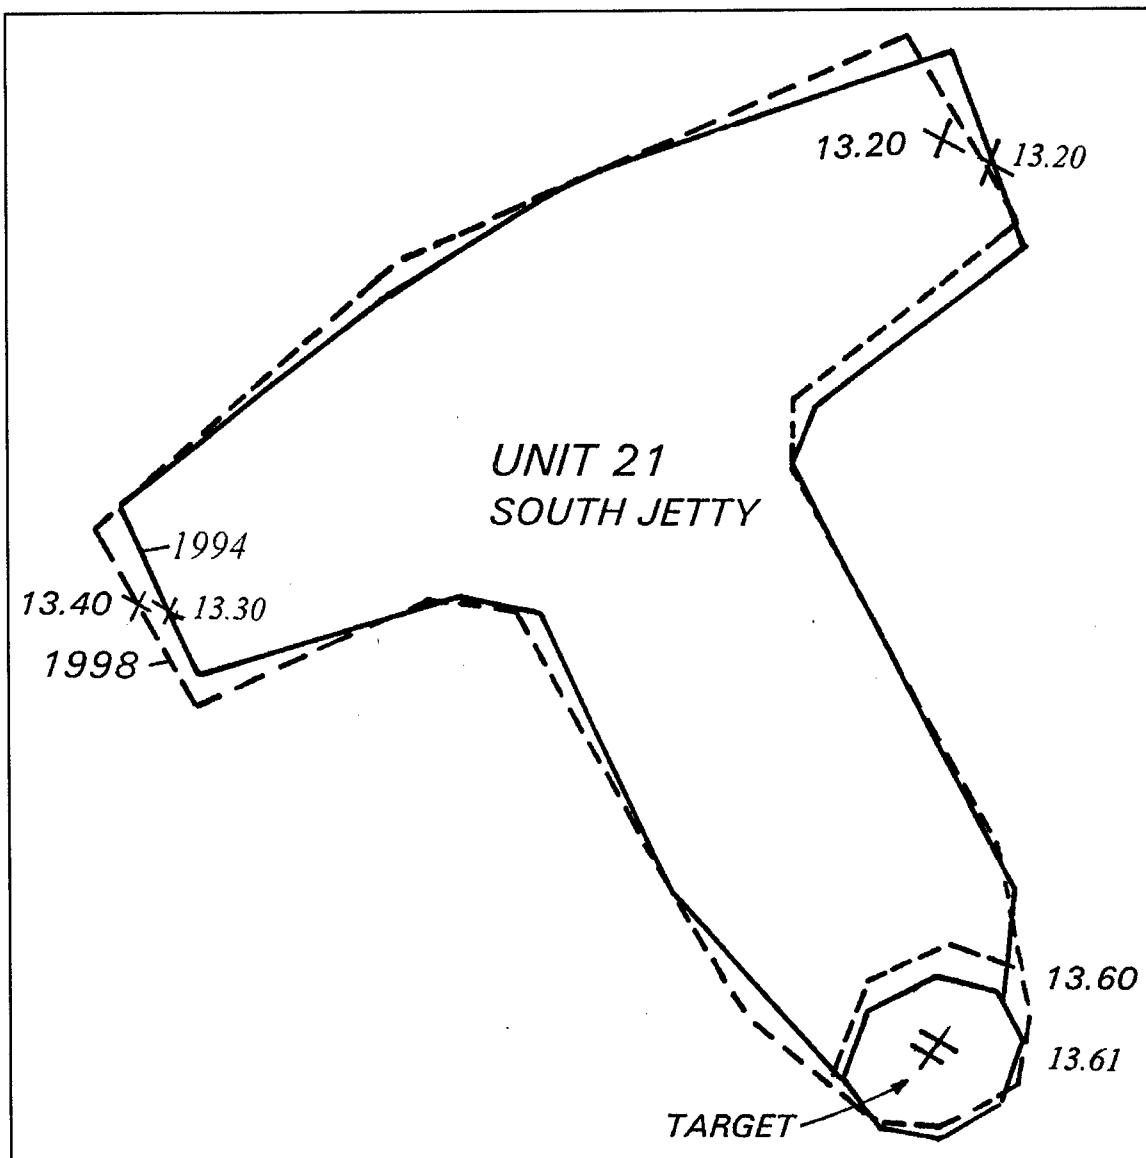
Figure 28. Example of horizontal position of a target dolosse armor unit and additional elevations obtained for 1994 and 1998 photogrammetric surveys

Comparisons of armor unit movement data to this point have included only target data and not movement of the entire armor unit. Therefore, to assess the motions of the entire armor unit, outlines of each targeted dolos were extracted from the stereo models and compared for the 1994 and 1998 surveys. These comparisons depicted horizontal positions, and actual distances moved were scaled off the photogrammetric maps that were prepared. To determine vertical movements of the targeted armor units, additional elevations were obtained from the stereo models at one or two additional points on the dolosse (points other than the established targets). An example of the position of a targeted armor unit and additional elevations for the two surveys is shown in Figure 28.

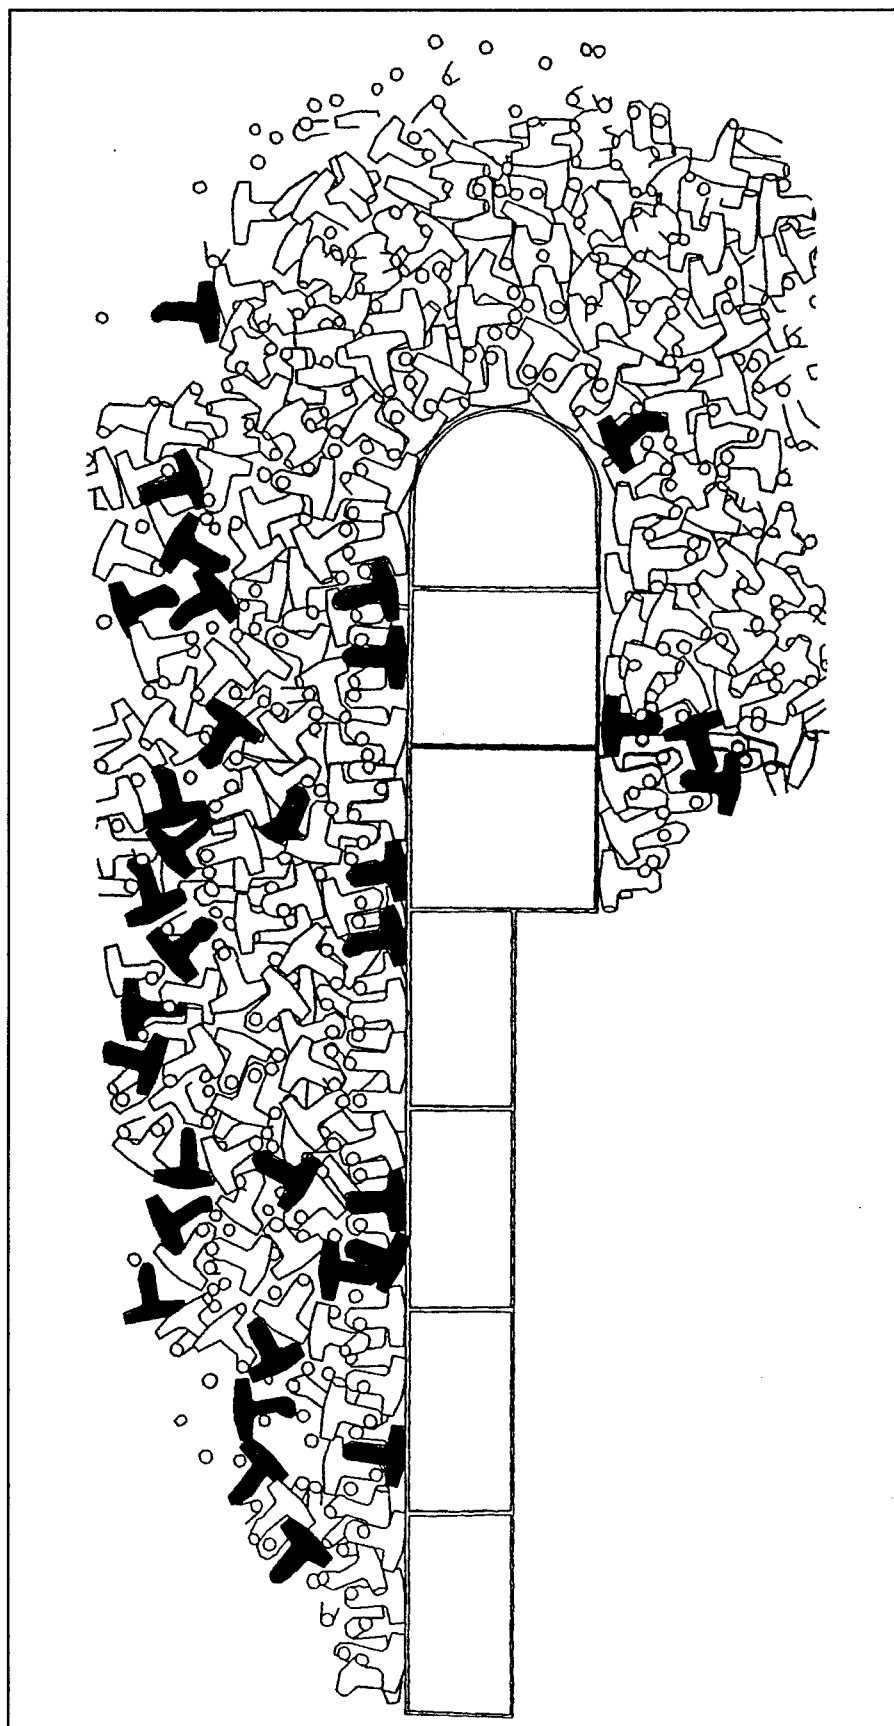
Figure 29. Nontargeted dolosse armor units selected for analysis on north jetty

In addition to the targeted armor units, additional (nontargeted) dolosse were selected on the north and south jetties for comparison of movement data between the 1994 and 1998 surveys. The locations of these additional armor units are shown in Figures 29 and 30. Thirty-three dolosse on the north and 29 on the south jetty were selected. Outlines of these additional dolosse, as well as elevations at two or three points on each unit, were obtained from the stereo models for the two surveys and compared on photogrammetric maps to determine horizontal and vertical motions, similar to the procedures used on the targeted units.

Evaluation of the horizontal motions of the additional dolosse indicated that movement was relatively uniform for over half of the armor units, in that the entire unit tended to move in the same direction (nonrotational movement). Forty-five percent of the dolosse on the north jetty and 32 percent of those on the south jetty slightly rotated in either a clockwise or counterclockwise direction. Considering the rotated armor units, there was a dominance of clockwise rotation on the north jetty, and counterclockwise rotation was dominate on the south jetty. In general, of the additional (nontargeted) armor units analyzed that

rotated on the jetties, the majority consisted of those oriented with the vertical fluke farther downslope and the horizontal fluke closer to the jetty center line. Between 1994 and 1998, maximum horizontal displacements for any point on the additional selected armor units were 0.122 m (0.4 ft) on both the north and south jetties. The averages of the maximum horizontal movements of the additional selected dolosse, between 1994 and 1998, were 0.043 m (0.14 ft) and 0.064 m (0.21 ft) for the north and south jetties, respectively. Sixty-six percent of the units on the north jetty and 55 percent of those on the south jetty had maximum horizontal movements of 0.061 m (0.21 ft) or less at any point on the additional selected (nontargeted) dolosse. In general, based on the photogrammetric
